Part II

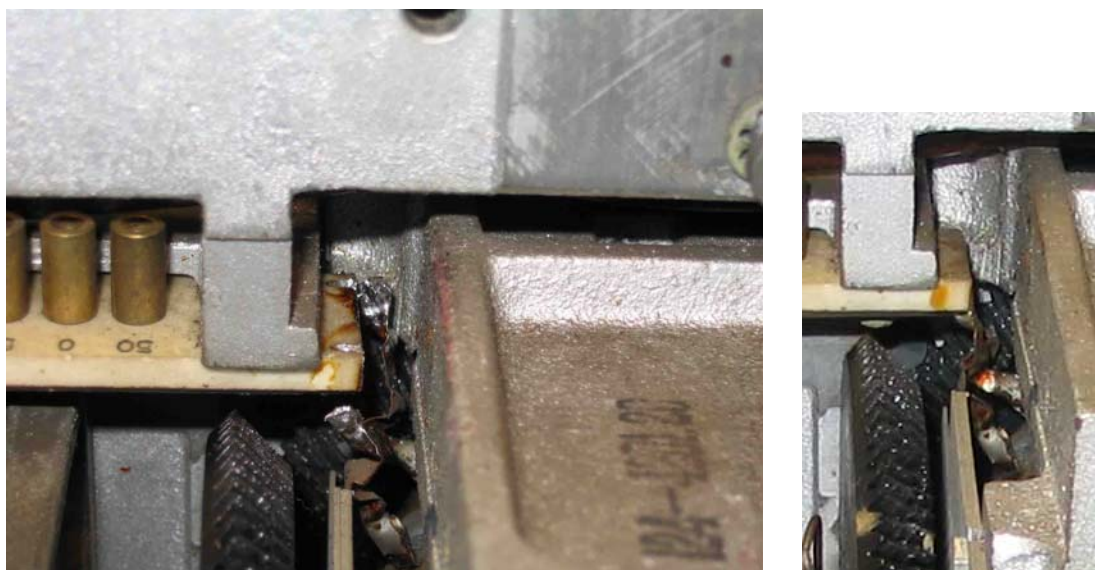
Photo 24 and Photo 24x

The next step is, to de-solder (disconnect) the flat-leads of the oscillator tuning C and the ceramic plate(mounting) (regard also photos 38/39, **Part III**). The second photo might give an impression how narrow the space actually is.

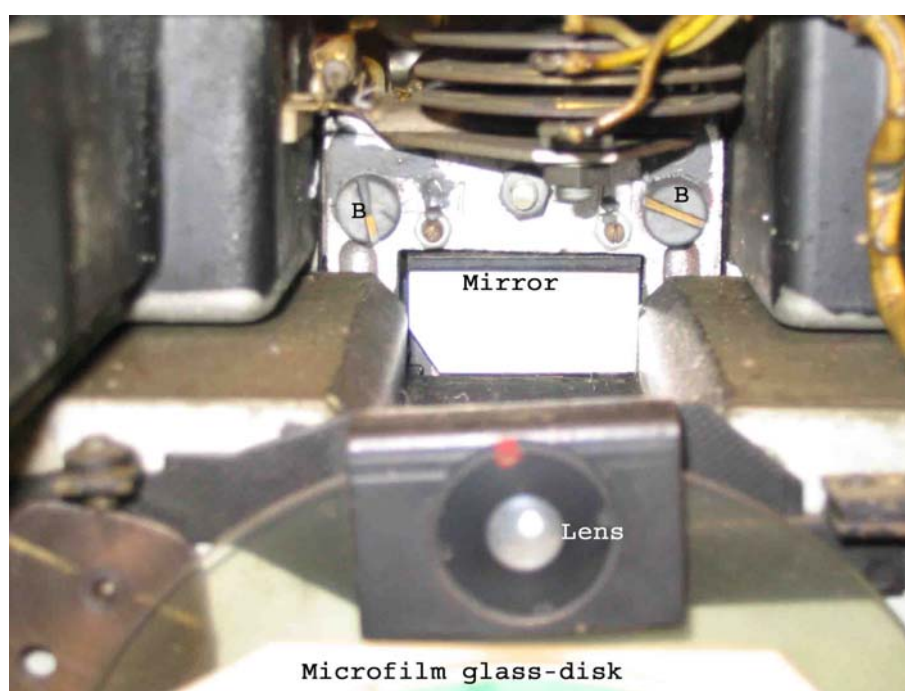
Photo 25

Both bolds B (right and left of the mirror) has to be detached, as to prepare for detaching the tuning-unit. The microfilm glass (scale)disk is mounted just behind the first optic lens. The transparency of the microfilm glass-disk indicates, that it is an: “Einheitsskala”, thus not individually being calibrated. **Keeping production parameters** is becoming more important!

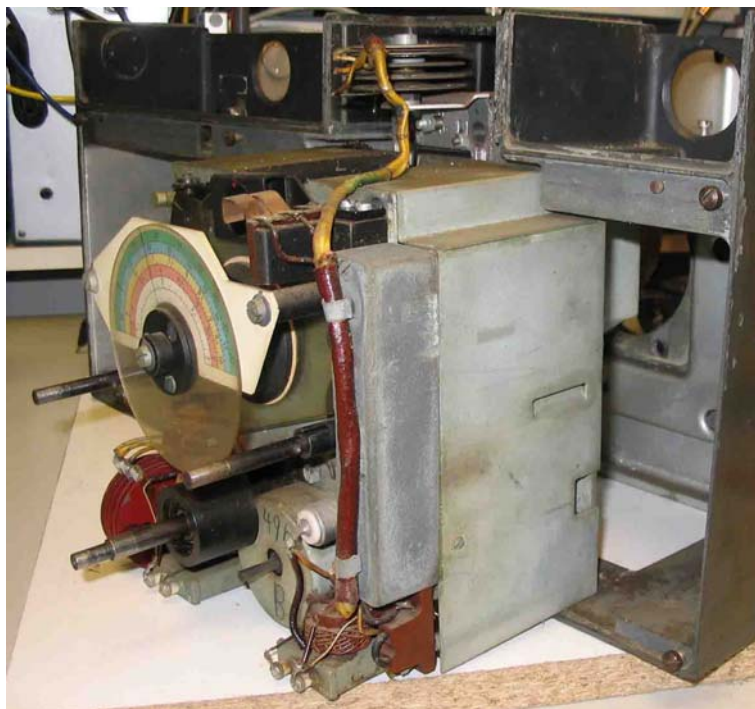
Photo 26

After having detached also two bolts at the rear, the tuning module can carefully be pulled forward. The two pin socket down on the right, is meant to connect (assemble) a remote-control unit at the front-side of the Köln receiver. However, although its existence appears in a Luftwaffe stock list, no one, to my knowledge, has ever actually seen such a device. A picture of its (not yet finished) prototype can be, nevertheless, found in: **Luftboden-Programm** catalogue of 1941, which is provided at this website.

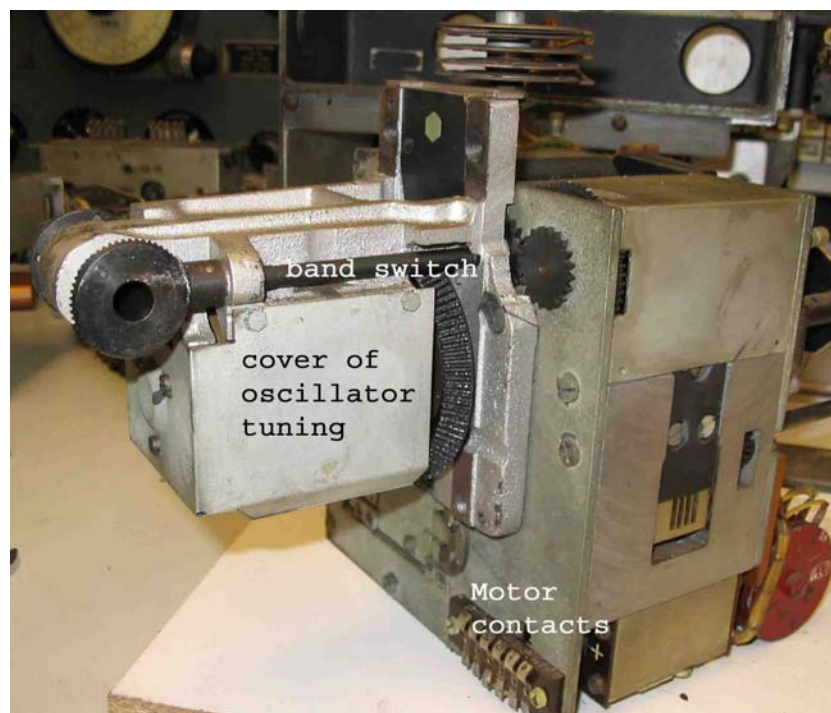
Photo 27

Rear vision of the tuning module. Consider the solidity of the die-cast frame(Al. paint)!

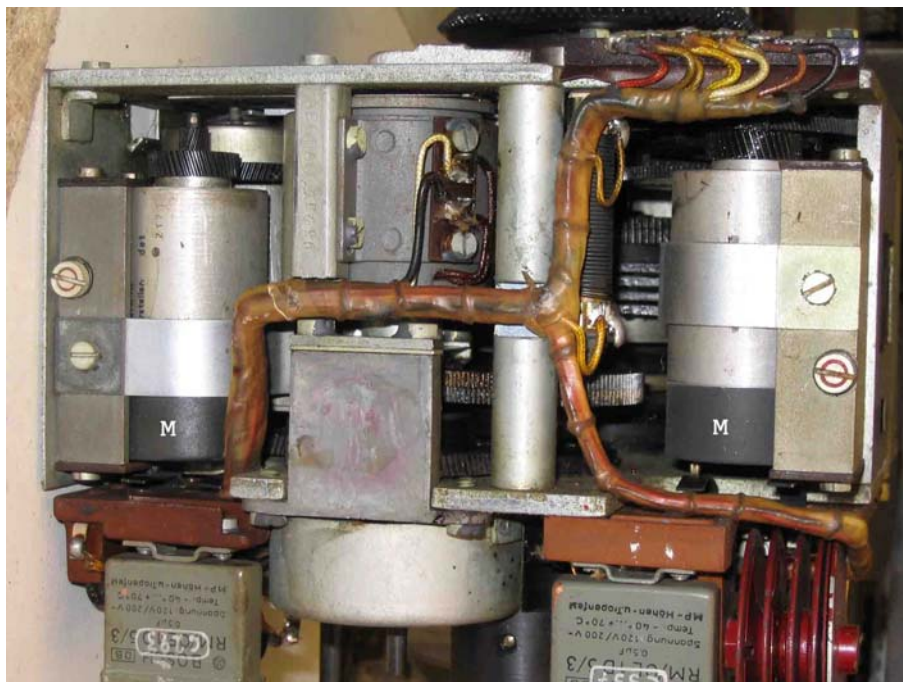
Photo 28

The two miniature driving motors are being marked 'M'. One is used for driving the band-switch, the second for tuning at 1 out of 4 selected spot frequencies (10,000 r/m, to overcome the: zero-momentum-clutch). I have demonstrated my own Köln type E 52a in the 1970s. And could return it to a spot frequency set in the 40 meter band tuned at an SSB QSO. It returned after switching through all ranges and frequencies to a clear SSB conversation again. This meant within +/- 10 to 15 Hz

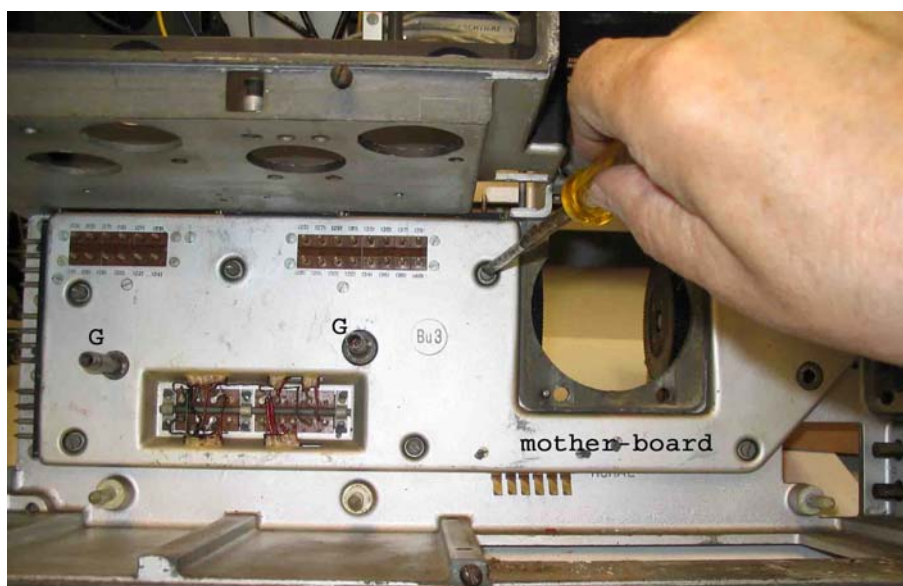
Photo 29

The next step is, to remove the central wiring Bü3, which I would like to call: mother board, as it represents the entire interconnecting wiring! G are shafts for fixing modules. Which are only kept mounted(position) by means of one lock-screw only (regard page 4 again)

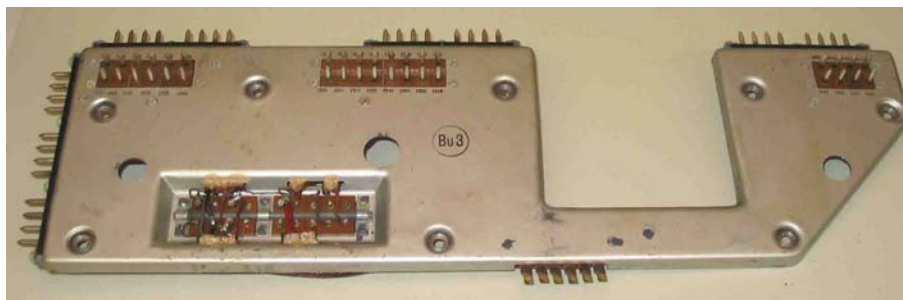
Photo 30

The various connectors can clearly be recognized. The contacts pointing to the left, were meant as to connect a HF/DF adapter. Which, like the remote-control system, never reached actual service. Nevertheless, there might have existed a so-called “Null-Serie”, which meant a few, more or less, hand made samples. See **Luftboden-Programm** at this website

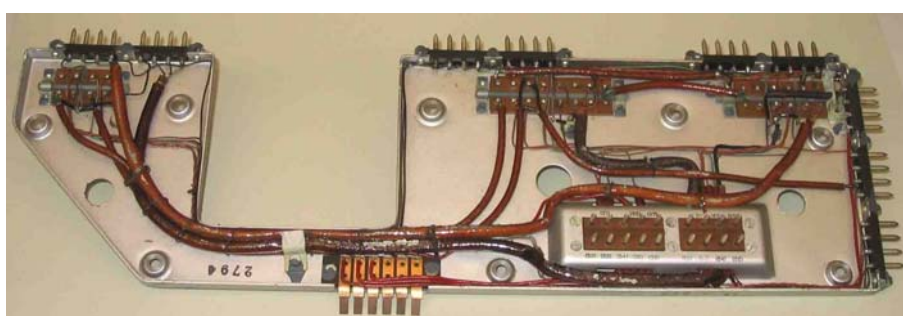
Photo 31

Shown is: the entire interconnecting wiring of a Köln receiver! The contacts pointing towards us, are to connect the power supply module. The silvered contact fingers, is to connect the tuning module. The HF/DF contacts are now facing to the right. The power supply unit has sufficient capacity to feed both Köln and the HF/DF adapter

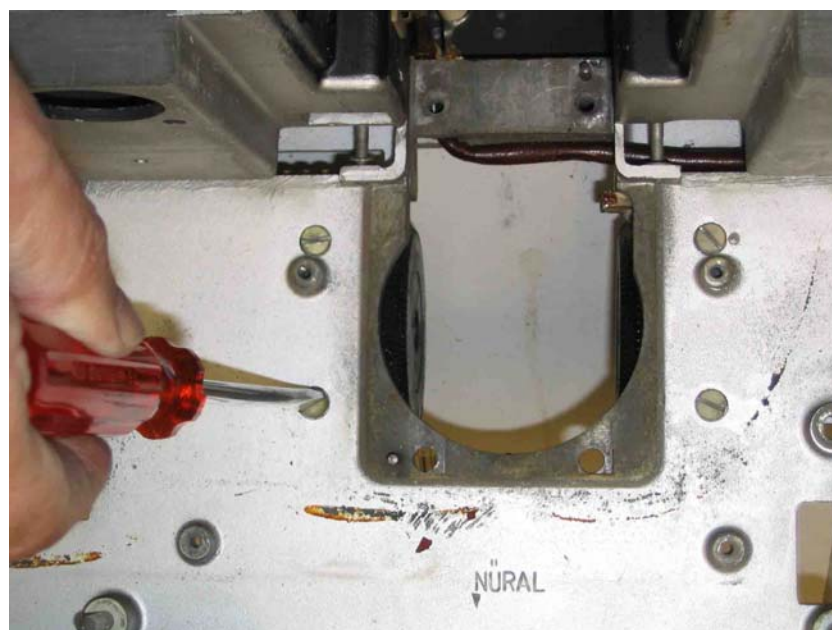
Photo 32

The next step is: to detach the bolts holding the tuning-capacitors

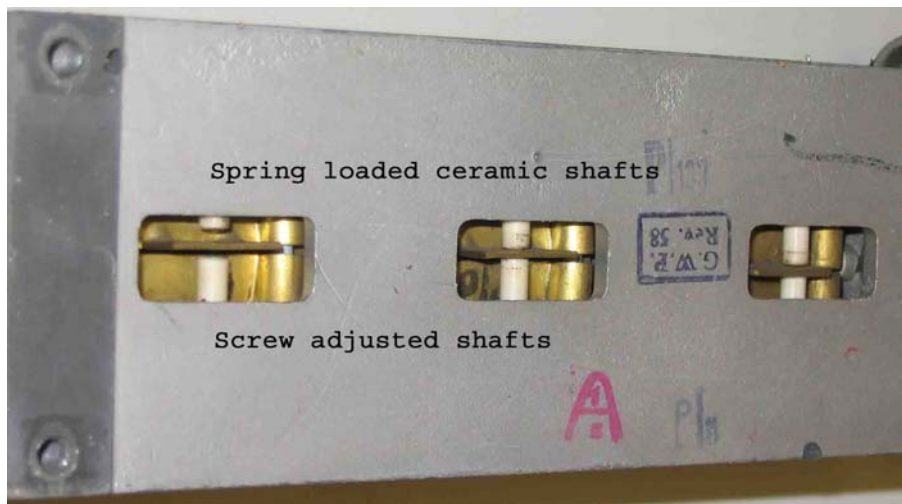
Photo 33

On the left side we see the “corpus delictum” We can also see, that each tuning capacitor section has its individual “zero setting”. We must regard, that this was the setting where all tuning capacitors had their maximum capacitance

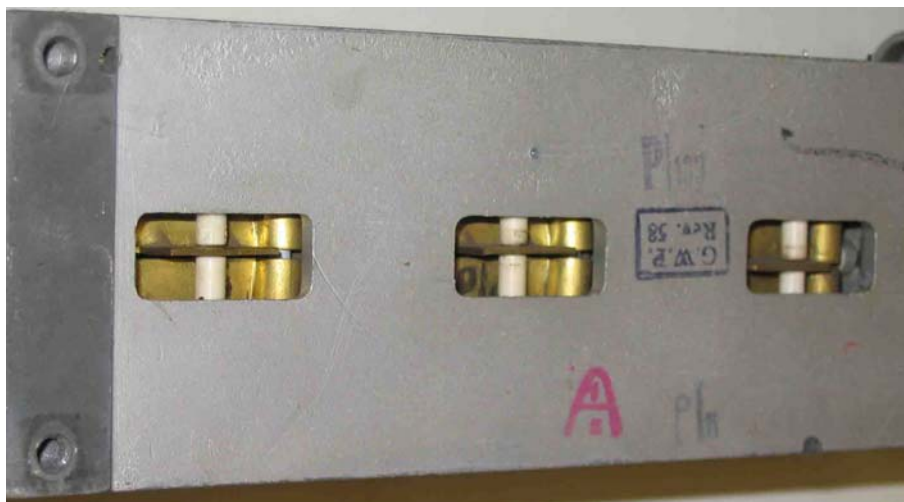
Photo 35

The free movement of the spring loaded ceramic shafts have been restored

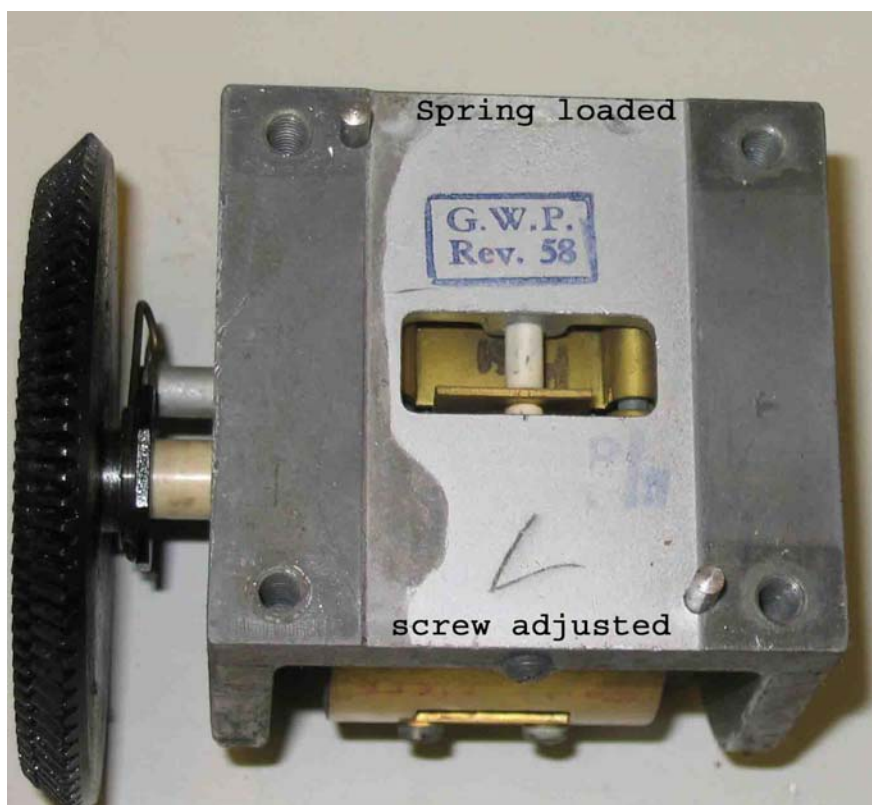
Photo 36

The tuning capacitor of the mixer stage. If we look back at previous photos, then we may recognize that the rotation direction of the per-amp stages and mixed stage are rotating in opposite directions. Which, due to its universal design, does not provide problems. The adjusting (alignment) screw is good visible.
