Part III

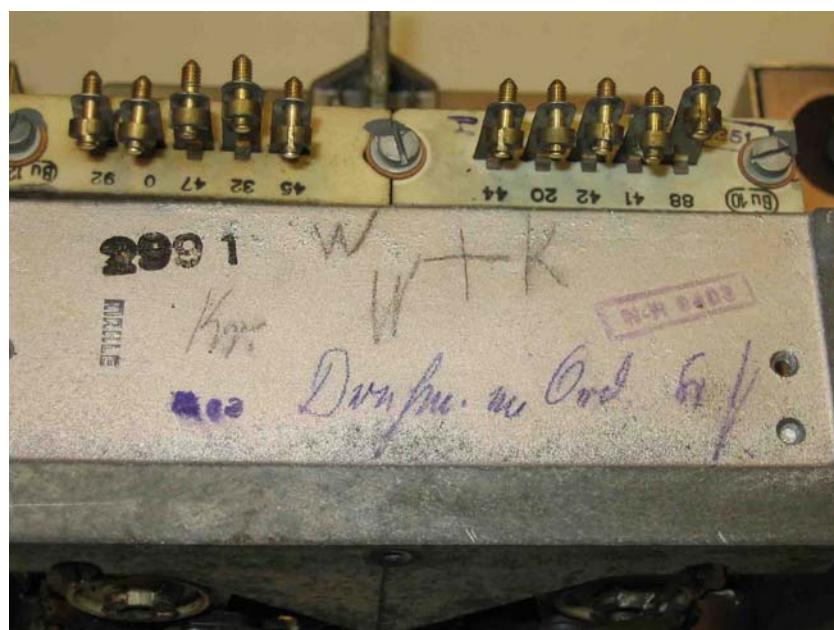
Photo 42

The second RF band-filter tuning block. The various texts, might provide some state of affairs

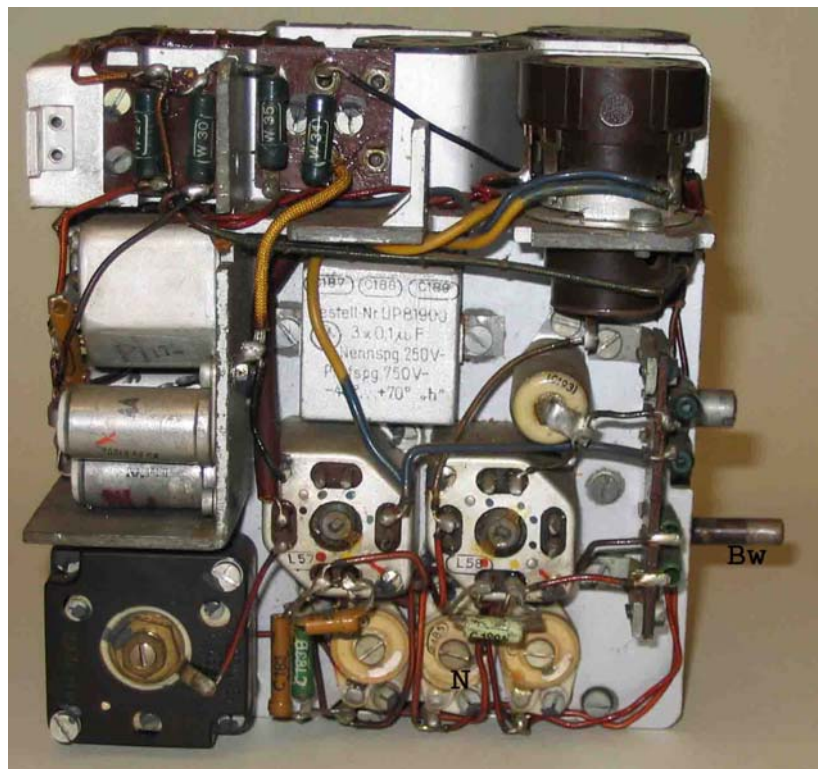
Photo 45

Bw is the bandwidth tuning between 200 and 10,000 Hz. Its curves stays symmetrical. This type of quartz-filter-tuning tends, however, to unwanted side-lobes. I believe, that the six filters (in this case only 5) situated between mixer output and grid 1 of the first IF stage (see schematic at page 4), had to nullify (minimize) this side effect. These lobes can only occur when the band-filter-tuning is being set about middle of the bandwidth response. However, tuned at very narrow or wide band-pass response, no (unwanted) side lobes can be noticed. Please consider next the IF band-filter response, which was very kindly measured (plotted) about 1990 at the Philips Quartz factory, in Doetinchem* (NL), by Donald Prins (thus is not originating from Köln 2871). Impressing is its very large dynamic range, which might well compete with today's quartz filters. Especially when we realize, that it used only two filter quartz. One of their secrets is, that the Germans knew how to produce good, low loss, dust-cores coils. These IF coils necessitate a loaded Q of > 100 . Regarding its actual size (L57 – L 58), a very good achievement. This quartz filter type was invented by Kautter, be it on behalf of Telefunken (see also our: **Patent DE dBase**) (consider also page 4) and **Aspects of German electronic engineering in the 1930s** (Synopsis) *Factory changed hands to “Saronix” and then it went bankrupt about 2002/2003

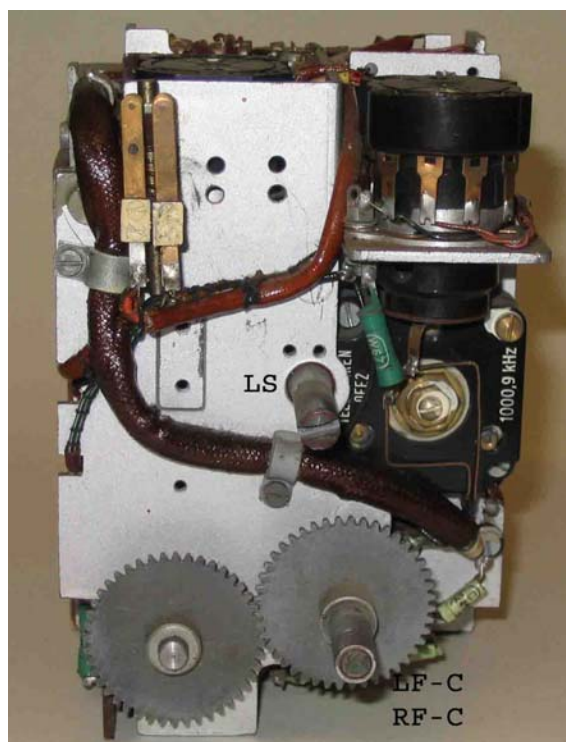
Photo 49

LS = central locking screw. RF-C + LF-C is audio or receiver RF gain. The empty holes, originate from the old (abandoned) variable BFO provisions

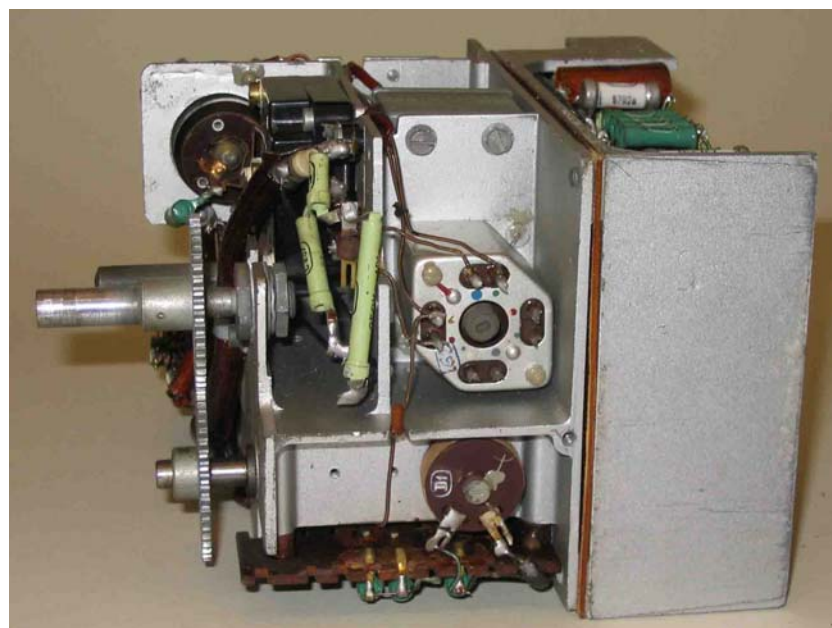
Photo 51

Bottom view of the module (extra screening being removed)
